# Infinity Testing Solutions

## Clevis Pivot Assembly Strength Test

**Report Number: 21010062 Revision 1**

Report for: **Conqueror Building Materials Inc.**  
3392 Colonial Drive  
Mississauga, ON L5L 5B9

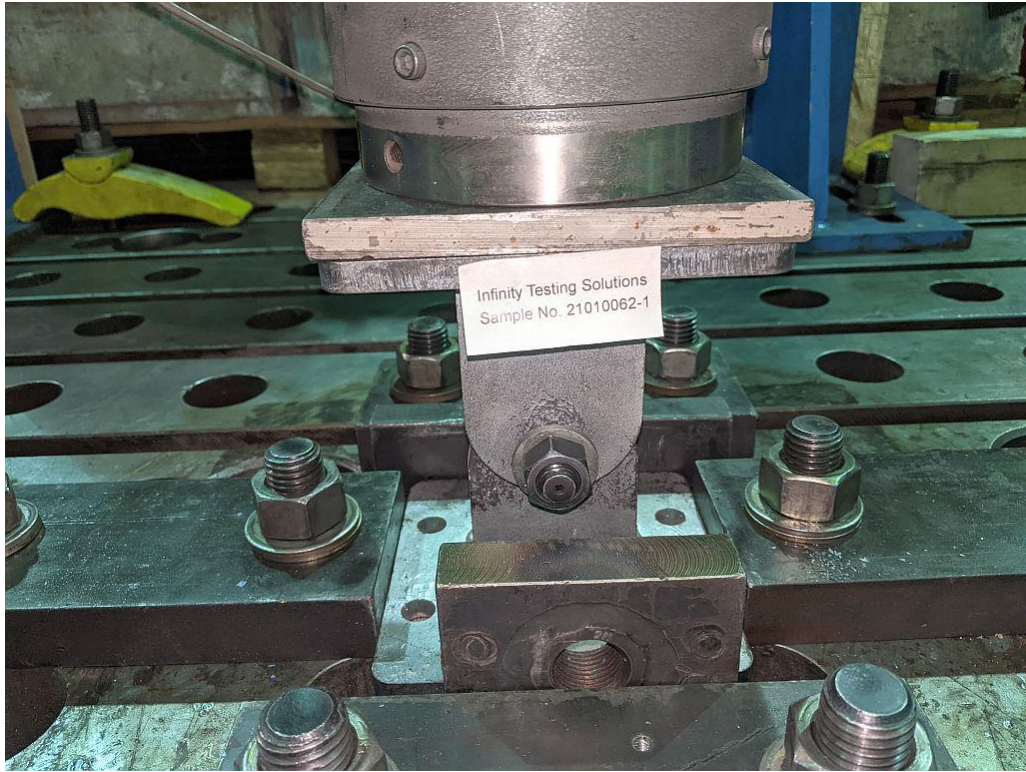
Figure 1: Test setup

Sample consisted of two clevises securing together via a 3/4" hardened alloy shoulder screw/pin with a Rockwell C32 hardness in a double shear setup. The sample was placed on the heavy-duty test bed and sandwiched between four securing plates to locate the sample beneath the load frame/actuator and prevent samples' base clevis from shifting during test. As shown in Figure 1 and Figure 2.

Setup and post-test photos are shown in Figures 1 through 4.

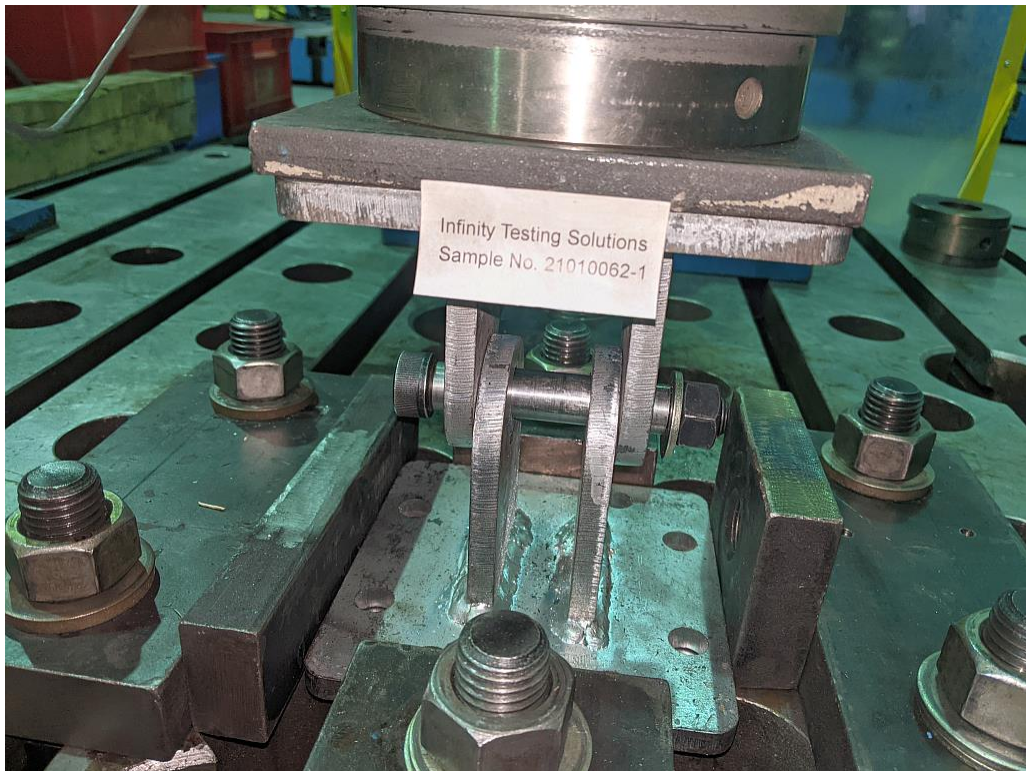
Figure 2: Sample during maximum load (43,000 lbf)

Sample Number	Achieved Load	Observations
21010056-1	43,000 lbf (191.3 kN)	Minimum deflection of clevis plate holes. Pin still easily removed

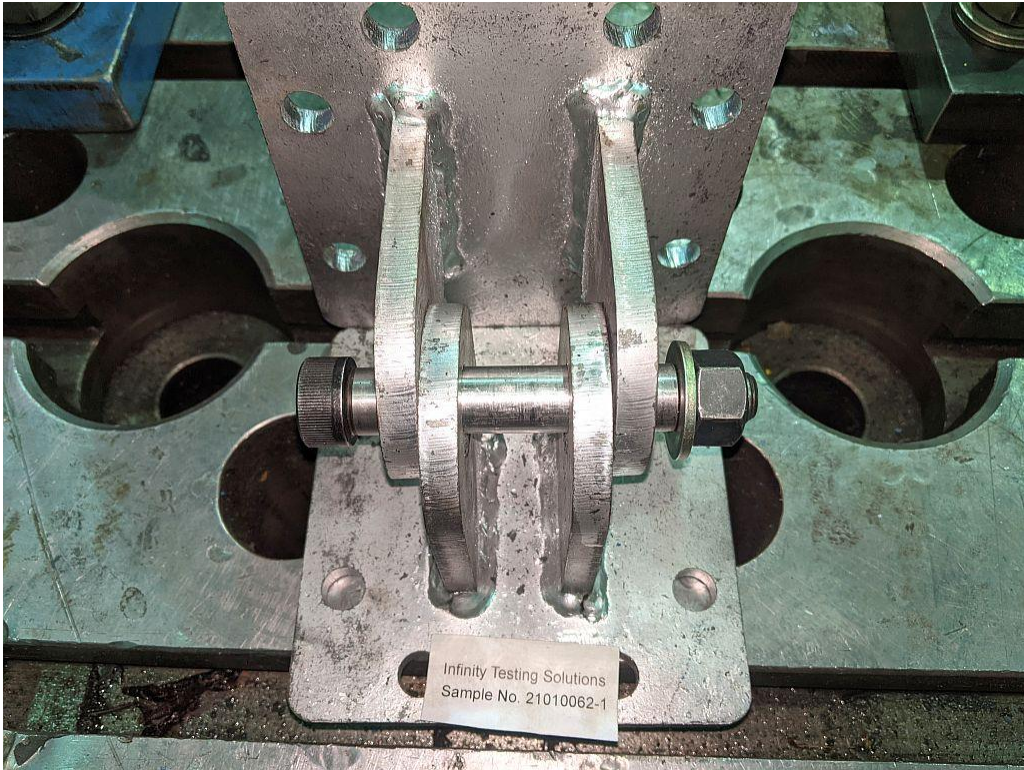
Figure 3: Clevis pivot assembly after testing

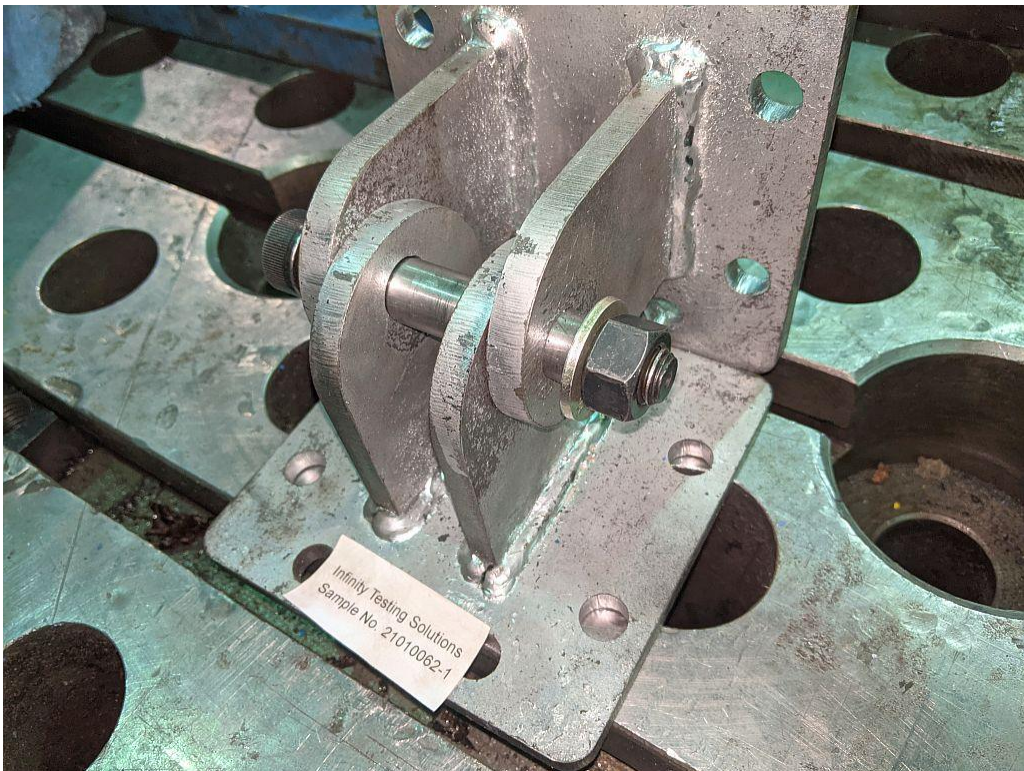
Figure 4: Clevis pivot assembly after testing

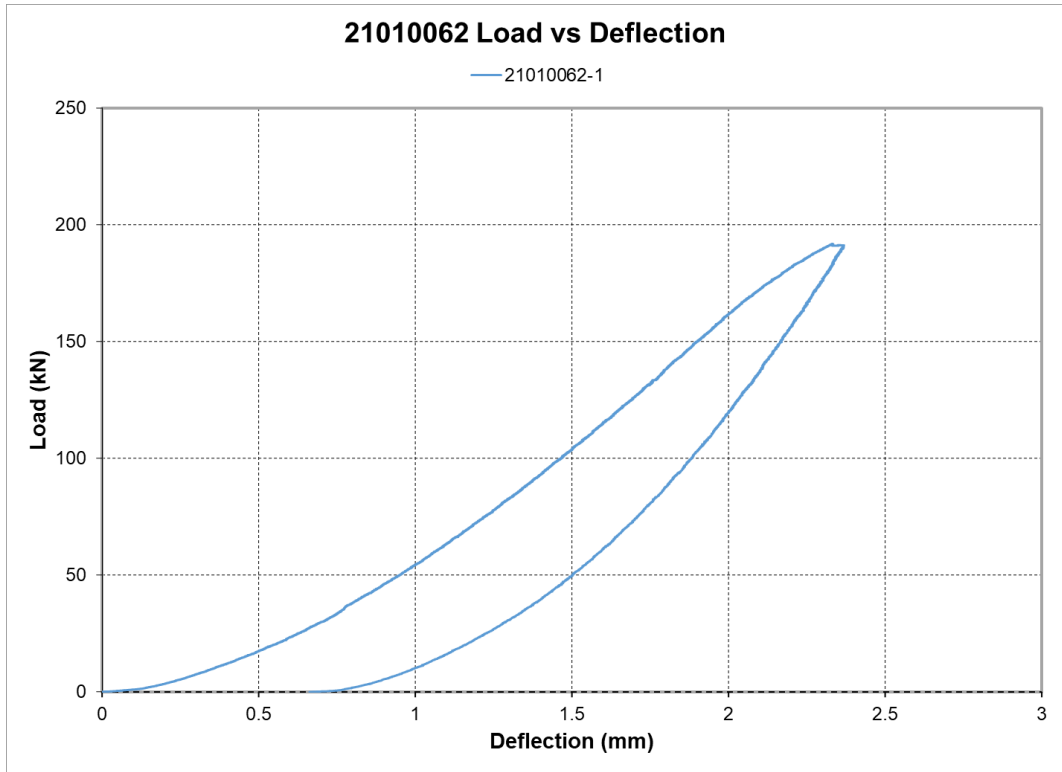
Figure 5: Load vs deflection chart

Load-deflection chart is shown in Figure 5.

Based on the observed load vs deflection curve during testing and signs that the sample could reach a yield point causing the sample to shear through the clevis plates. Under ITS advisement and clients’ decision, testing was concluded at the achieved load and after a hold time of 1 min to verify sample had not reached a yield point yet.
