Infinity Testing Solutions

Screw Jack Strength Test

Report Number: 22010058

Report for: **Conqueror Building Materials Inc.**
3392 Colonial Drive
Mississauga, ON L5L 5B9

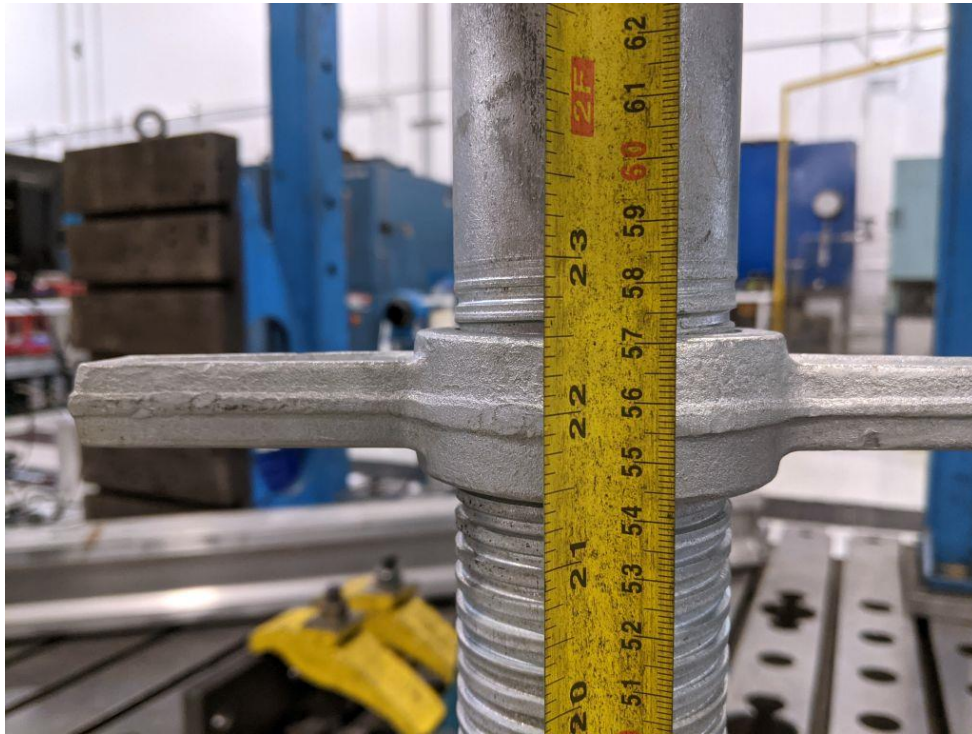
Figure 1: Clamp force test setup

The sample was extended to the manufacturer's maximum recommended extension, 22.5" (Figure 1). The free portion of the screw above the nut was placed inside a thick-walled tube fixture. For testing purposes, the sample and the fixture were oriented upside down and centred below the actuator, as shown in Figure 2. Load was increased at a constant rate of 5,000 lbf/minute until the client's target load of 50,000 lbf was reached. The load was then increased in increments of 5,000 lbf until reaching 65,000 lbf. Load was held for one minute at each increment.

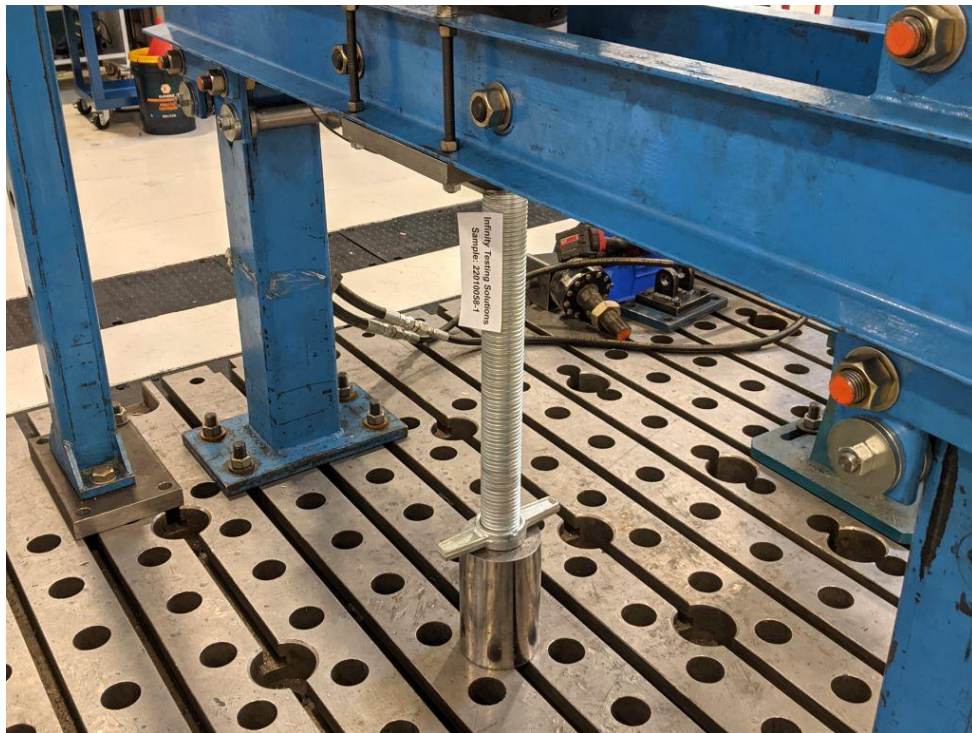
Figure 2: Clamp force test, hand tight + full turn, compressive load of 1,147 lbf

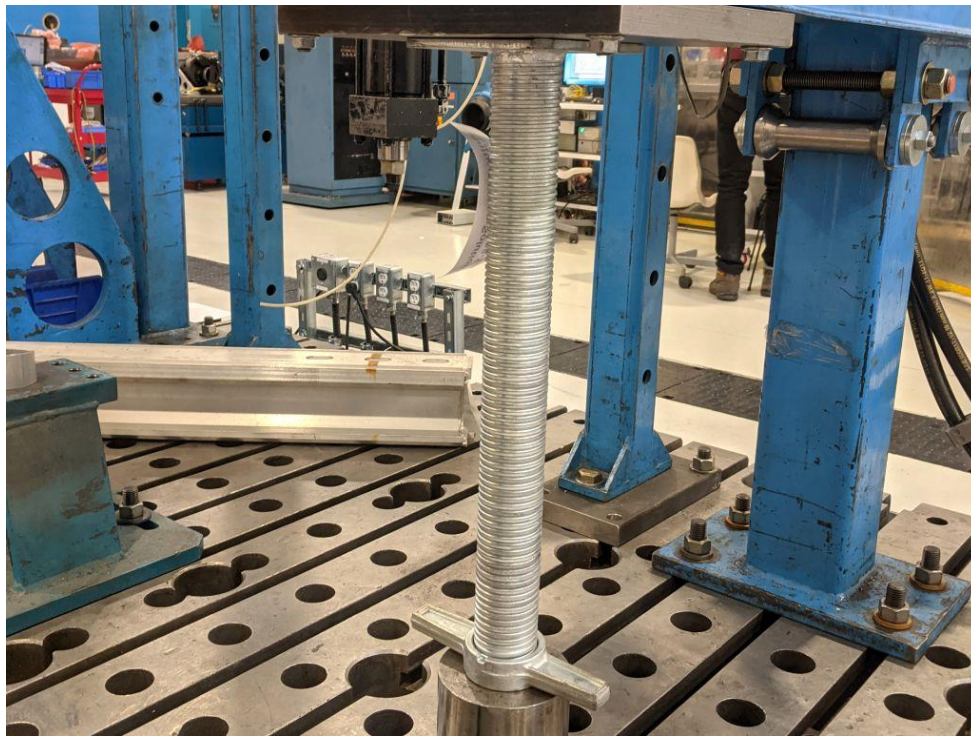
Figure 3: Sample 22010053-4 threaded tube moment capacity test setup

The same withstood a compressive load of 65,000 lbf with no visible deformations or failures. The nut was able to spin freely on the threads after testing. The sample during is shown in Figure 3. Recorded test data is shown in Figure 4.

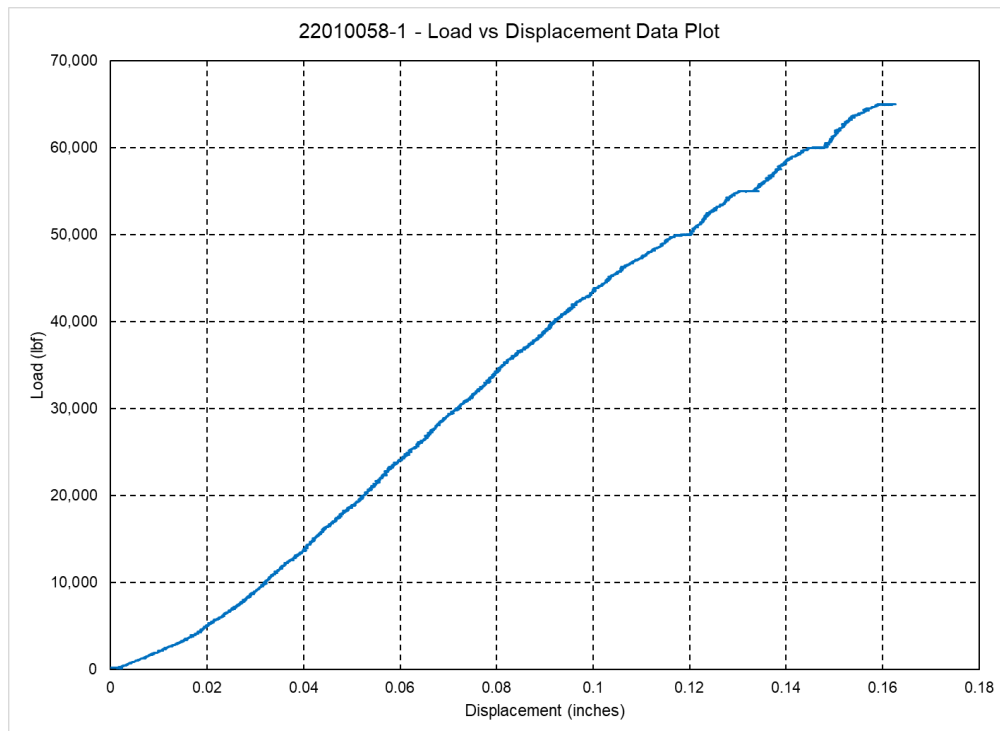
Figure 4: Load vs displacement data plot
