Infinity Testing Solutions

Concrete Slab Railing Post Strength Test

Report Number: 17010076B

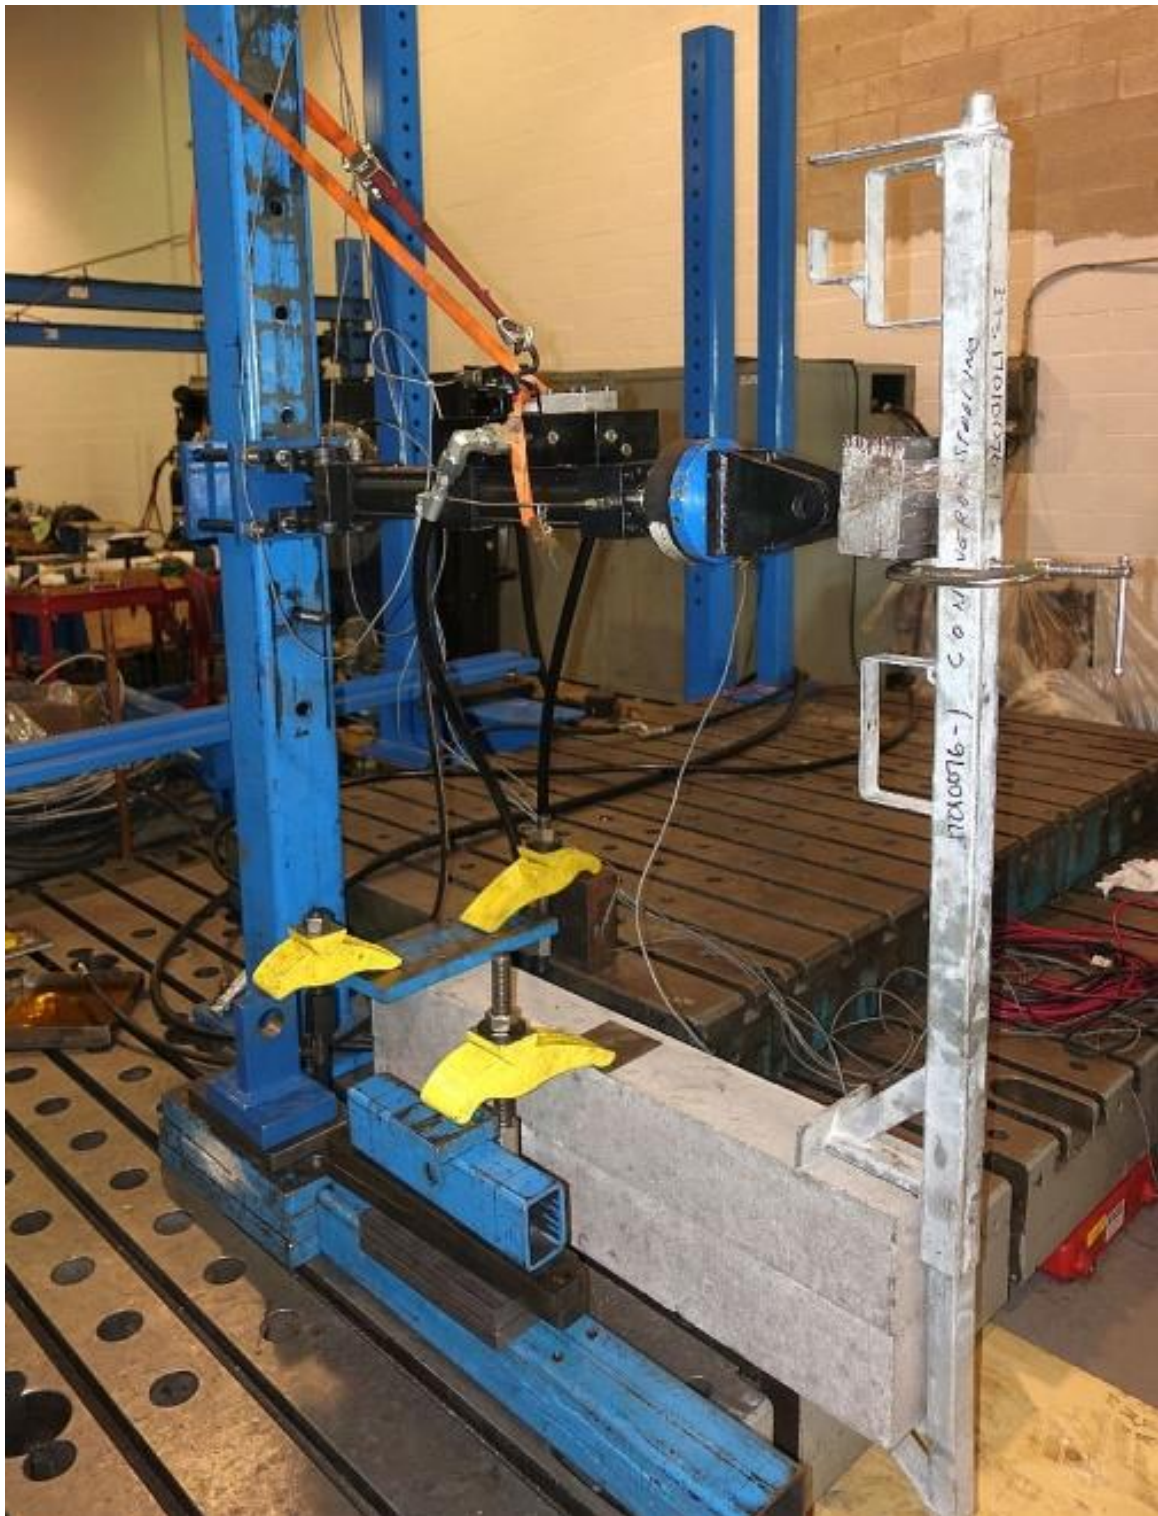
Figure 1: Test setup

Two concrete slabs, each 150mm in height, were stacked on top of each other and secured to a heavy-duty test bed. The sample was fastened to the concrete slabs according to the client’s specification. The actuator was positioned on the load frame such that the height of the loading point was 780 mm from the top surface of the concrete slab (Figure 1). Load was applied at a rate of 500 lbs/minute. Load and position data were recorded continuously a rate of 20 Hz.

Setup and post-test photos are shown in Figures 1 through 3. Load data is shown in Figure 4.

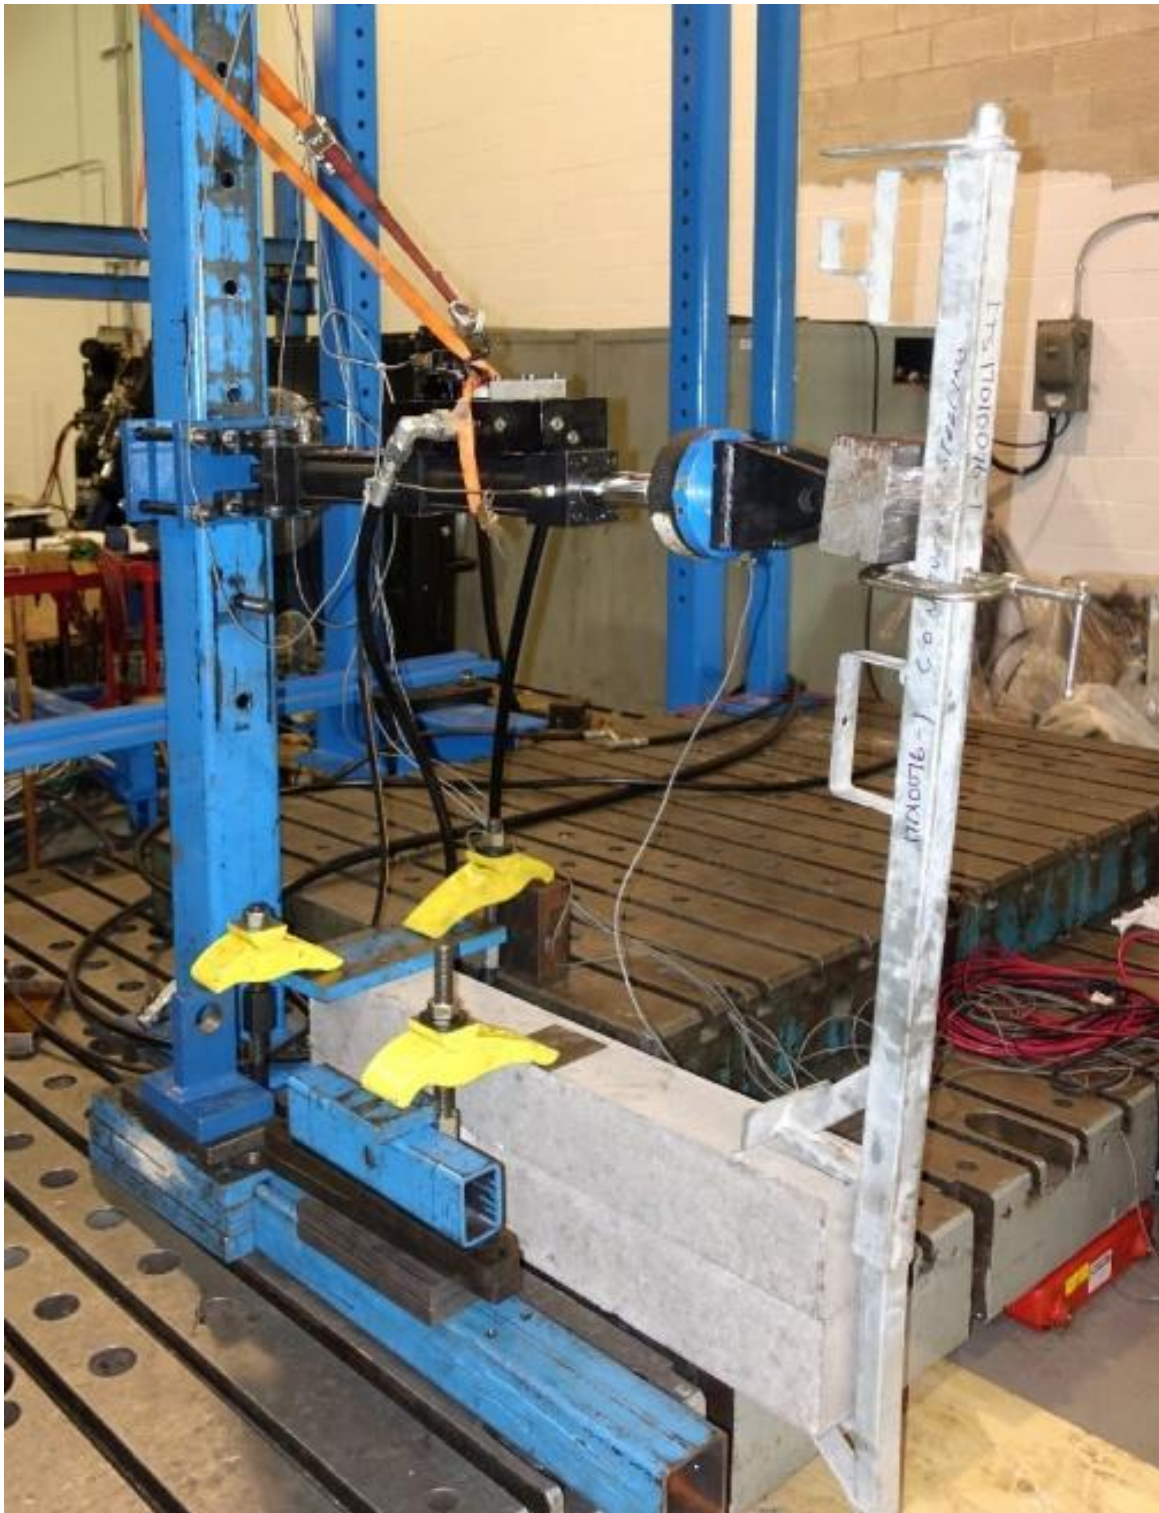
Figure 2: Maximum load (523 lbs)

Sample Number	Loading Height	Maximum Load
17010076-1	780 mm	523 lbs (2,327 N)

Note that load refusal had not yet occurred when the maximum recorded load was reached; the load was released prior to failure at the client’s request.

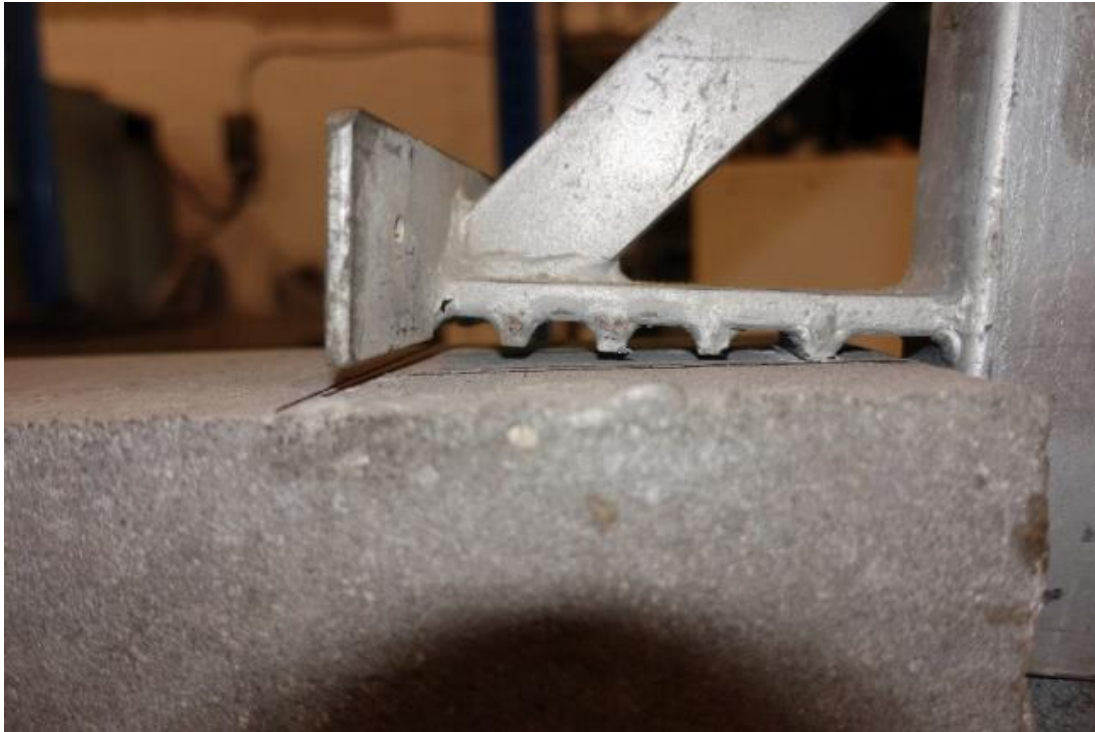
Figure 3: Clamp after testing

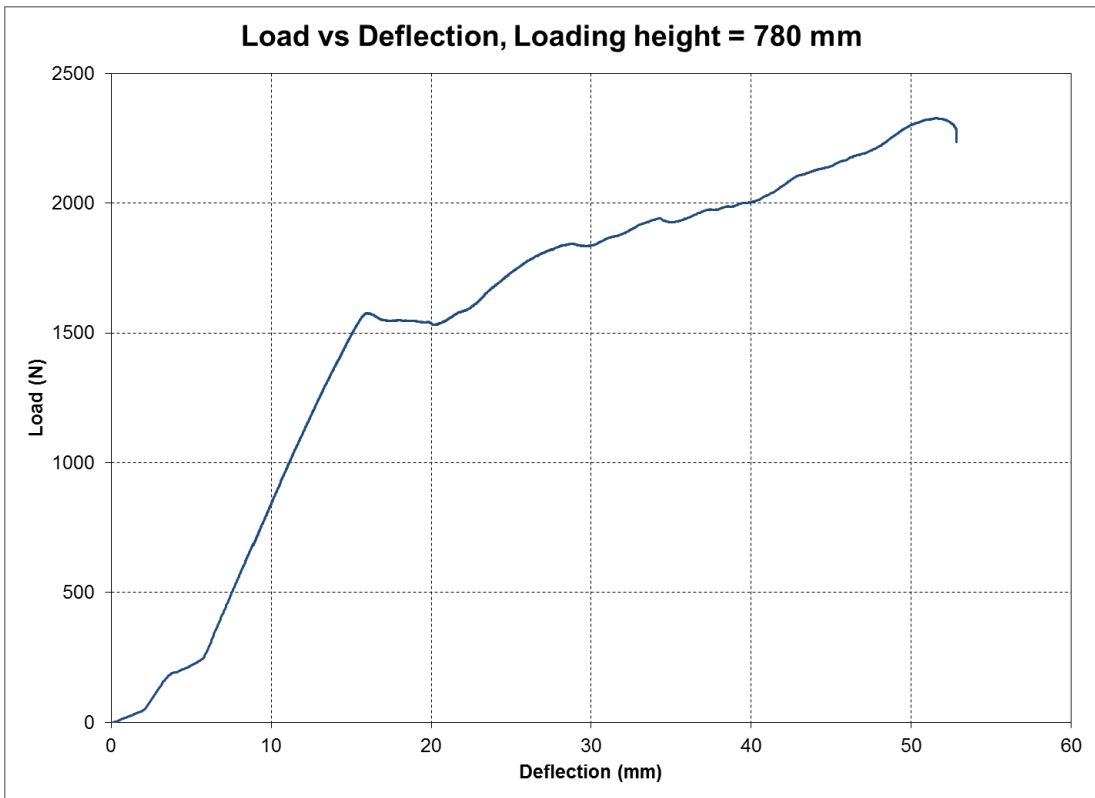
Figure 4: Load-deflection data plot
